Part 1

Foundations of Understanding

Review of Traffic Volumes + Patterns

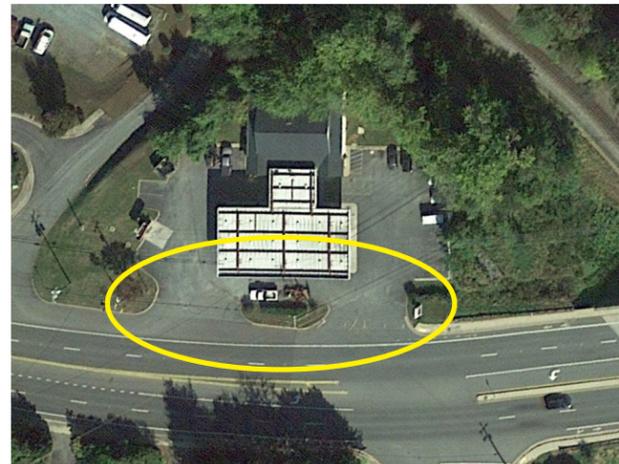
Image 1.1 - Non-Compliant Throat Length

Access Management Standards also consider the **Entrance Throat** of a commercial property as well as the entrance spacing. The minimum entrance throat depth for a commercial property is 26'. This distance is needed to safely transition vehicles to the internal circulation systems of the site. Image 1.1 and Image 1.2 below show examples of throat length from entrances along the corridor.

The existing conditions along the Rio Road Corridor as related to entrance throat length will be a determining factor in the case with which new amenities are introduced to the corridor. Imagine trying to expand a sidewalk into a shared use path along a site where the throat length is similar to that shown in Image 1.1.

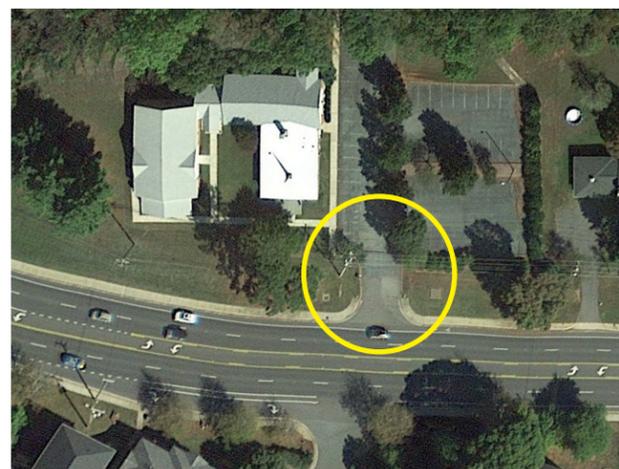
Image 1.2 - Compliant Throat Length

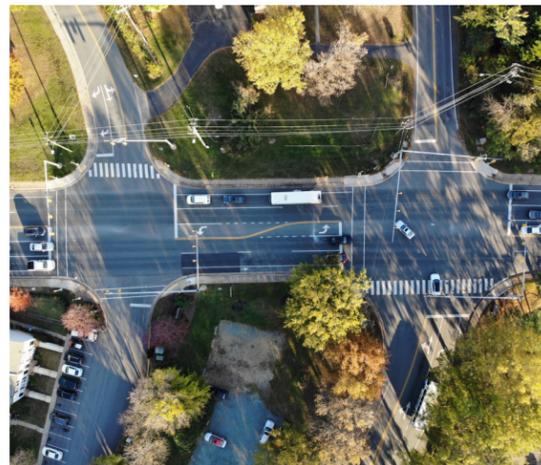
Image 1.4 - Intersection Spacing at Hillsdale + Old Brook

As was expounded upon in the "Access Management" portion of this study, these intersections are spaced approximately 220 feet apart (measured center to center). Put another way, this spacing is approximately 20% of what VDOT standards recommend. This also indicates that the turn lane storage lengths, taper lengths and intersection sight distances do not meet the minimum requirements.

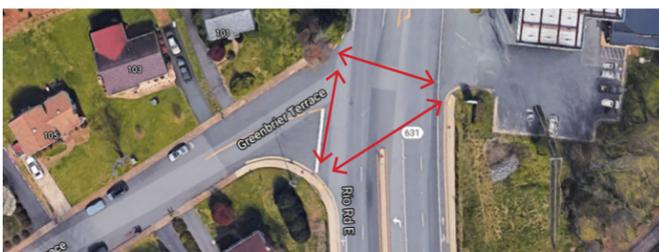
Image 1.4 - Pedestrian Confusion at Greenbrier Terrace

Apart from the frontage of the Exxon to Gasoline Alley, existing sidewalk facilities are present along both sides of Rio Road within the study area. These are mainly 5-foot-wide sidewalks, however in many instances the effective width is less due to encroachments from dense vegetation, railings, and other objects. The condition of the concrete in many locations is deteriorating as well. In addition to these conditions, all but the newest intersections have non-compliant ADA ramps. In many locations, ramps direct users into unsafe conditions, where pavement markings are not present. (Refer to Image 1.4, previous page)

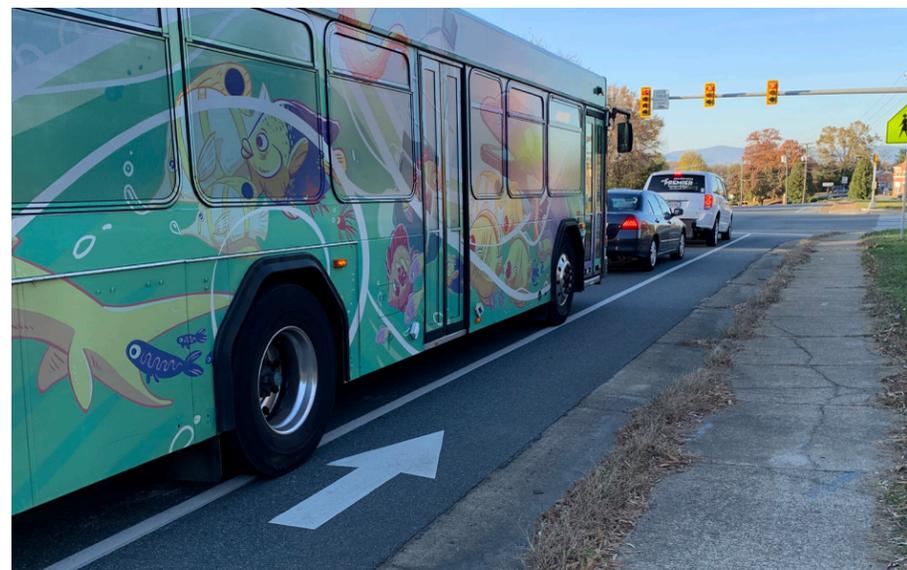
Image 1.5 - Multi-Modal Infrastructure

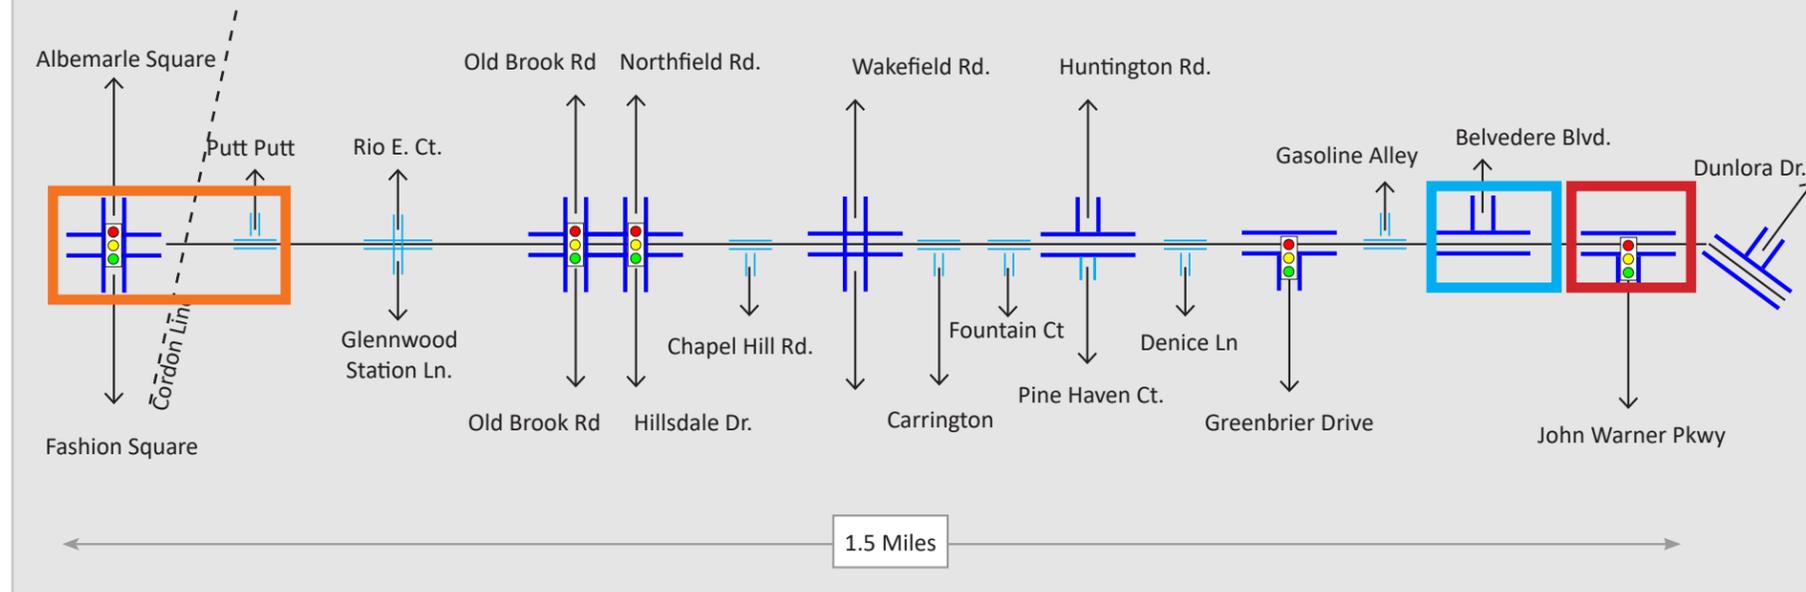
Figure 2.1 - Traffic Study Inventory

- Formal Traffic Study Completed (by others)
- Cursory Review by Line and Grade

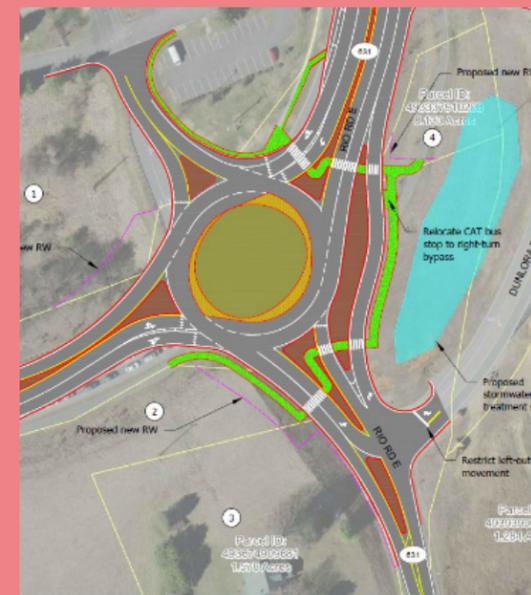
Figure 2.2 - Concept Plan From Study

The current low-level of service, the high crash frequency and the land ownership surrounding the intersection increase the viability of improving this intersection. Kittelson & Associates released a study of this intersection and recommended the intersection be improved with a dual-lane roundabout. The dual-lane roundabout suggestion seems rooted in the ability

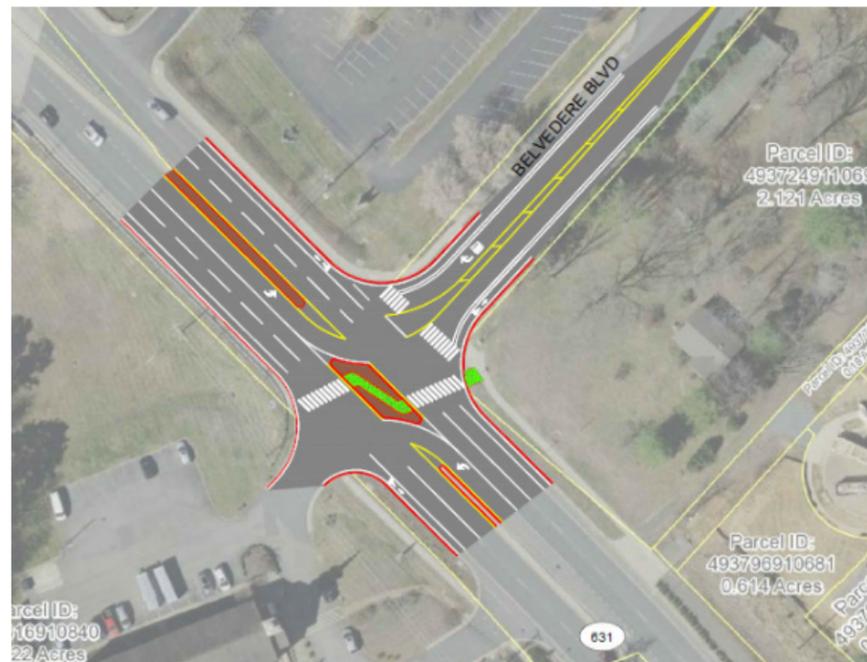
Figure 2.3 - Concept Plan From Study

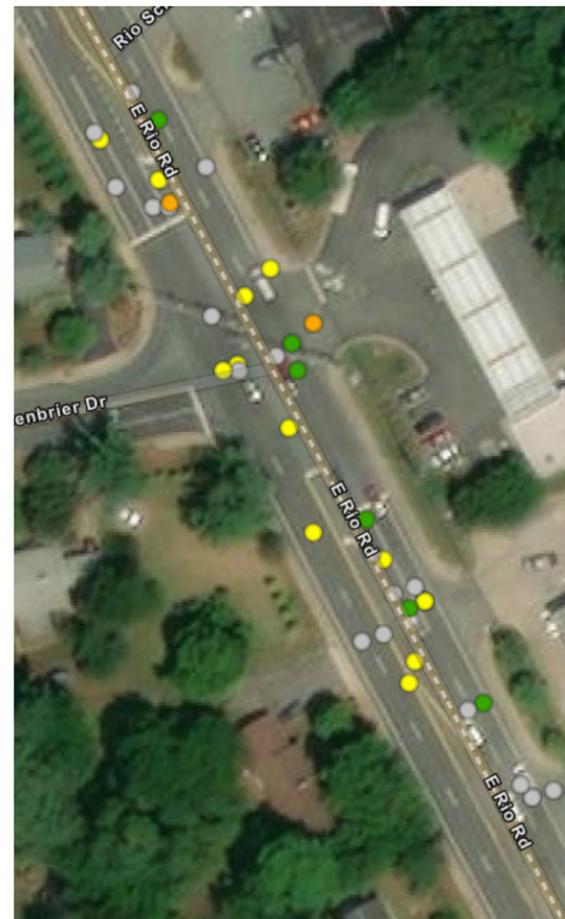
Figure 2.4 - Recorded Crash Data (VDOT)

The substandard spacing of entrances in this area contributes to numerous vehicular crashes, refer to Figure 2.4 for a graphic display of recorded accidents. As discussed in the Safety Criteria section, crashes are most likely at the conflict points of the intersection. The increased number of conflict points leads to increased crashes as shown in Image 2.4. The short, or non-existent throat lengths for commercial entrances contributes to the high crash volume as well. Refer to the "Review of Access Management" in Part 1 for more information on entrance throat standards.

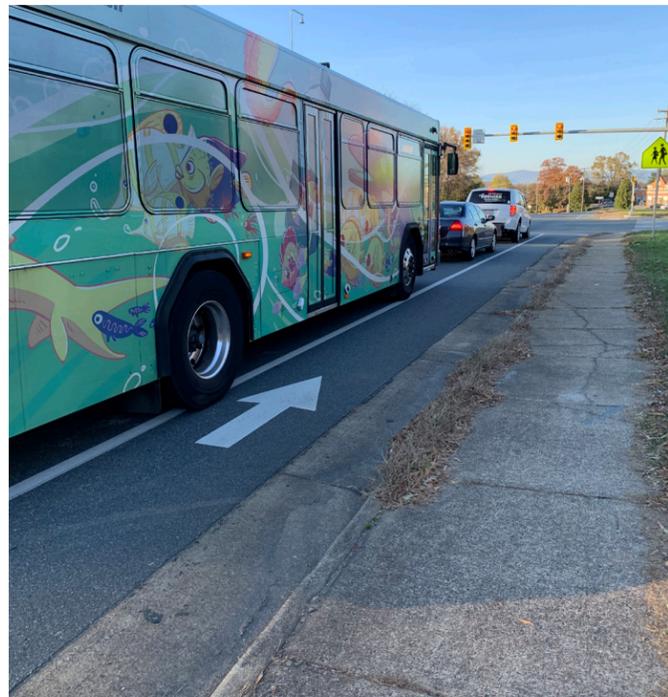
Image 2.4 - Rio Road between Old Brook and Northfield

(See image below). However, a number of factors prohibit a fully functioning multi-modal intersection. The lane widths in this area are 10 feet, which is 2 feet below the recommended lane width to accommodate a high percentage of buses (pg 18 VDOT Appendix A-1, figure GS-6). The high public transit traffic in this area combined with substandard lane widths and unbuffered bicycle lanes creates an unsafe, or at the very least unpleasant, condition for bicyclists. Picture yourself as a cyclist in Image 2.4 below.

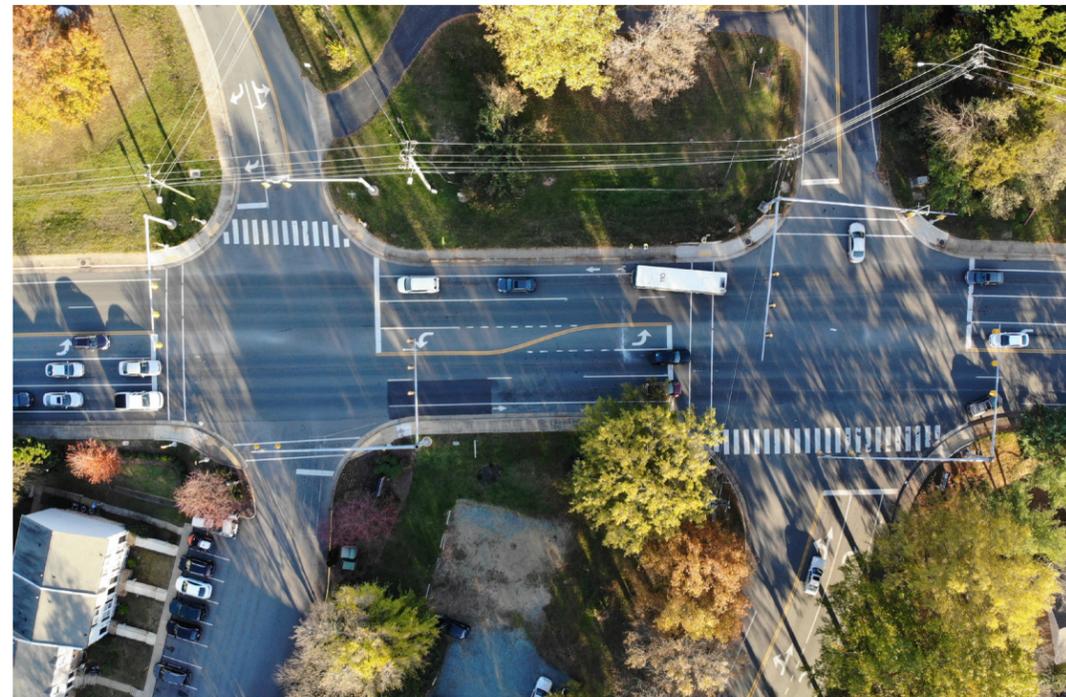
Image 2.5 - Aerial Image of Rio Road between Old Brook and Northfield

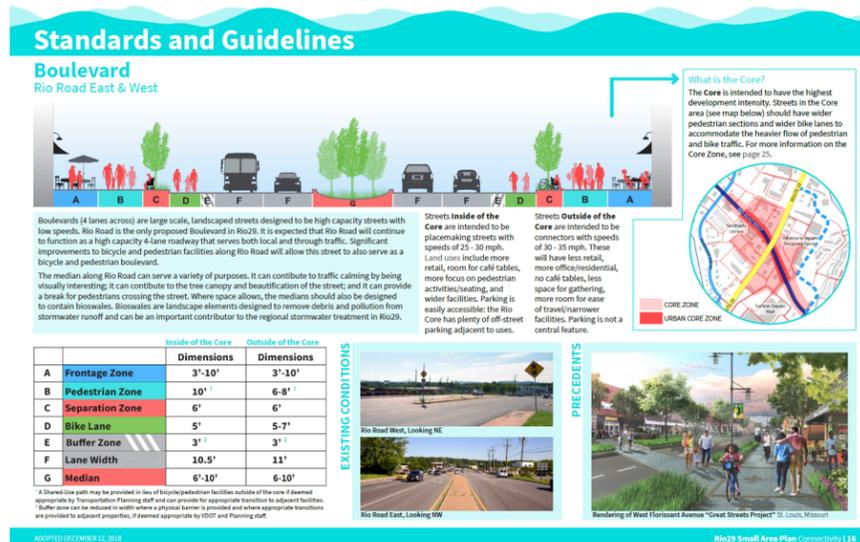
Figure 2.5 - Design and Guidance from the Rio/29 Small Area Plan

As Rio Road East approaches US 29, it begins to serve more commercial uses in addition to residential. The Rio29 Small Area Plan includes analysis of this portion of Rio Road, recommending it become a Boulevard with buffers for pedestrians and bicyclists and landscaped medians as a traffic calming measure. Redesigning this portion of the road would allow for an urban center, referred to as the core, around US 29 that is more inviting and safe for pedestrians.

Though a concept for this realignment and roundabout is included in the SAP, it has not been submitted for funding and there are currently no plans for construction.

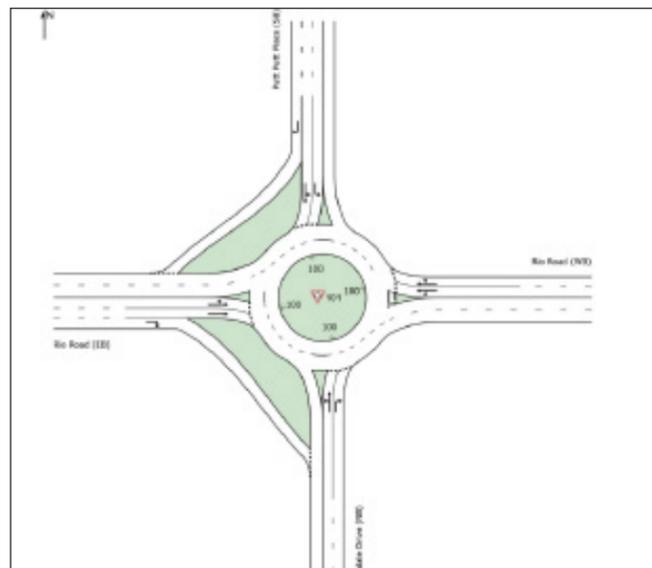
Figure 2.7 - Dual Lane Diagram for Hillsdale / Putt Putt Intersection
